KINGTOWN MILL

HAER No. NJ-118

WRITTEN HISTORICAL AND DESCRIPTIVE DATA

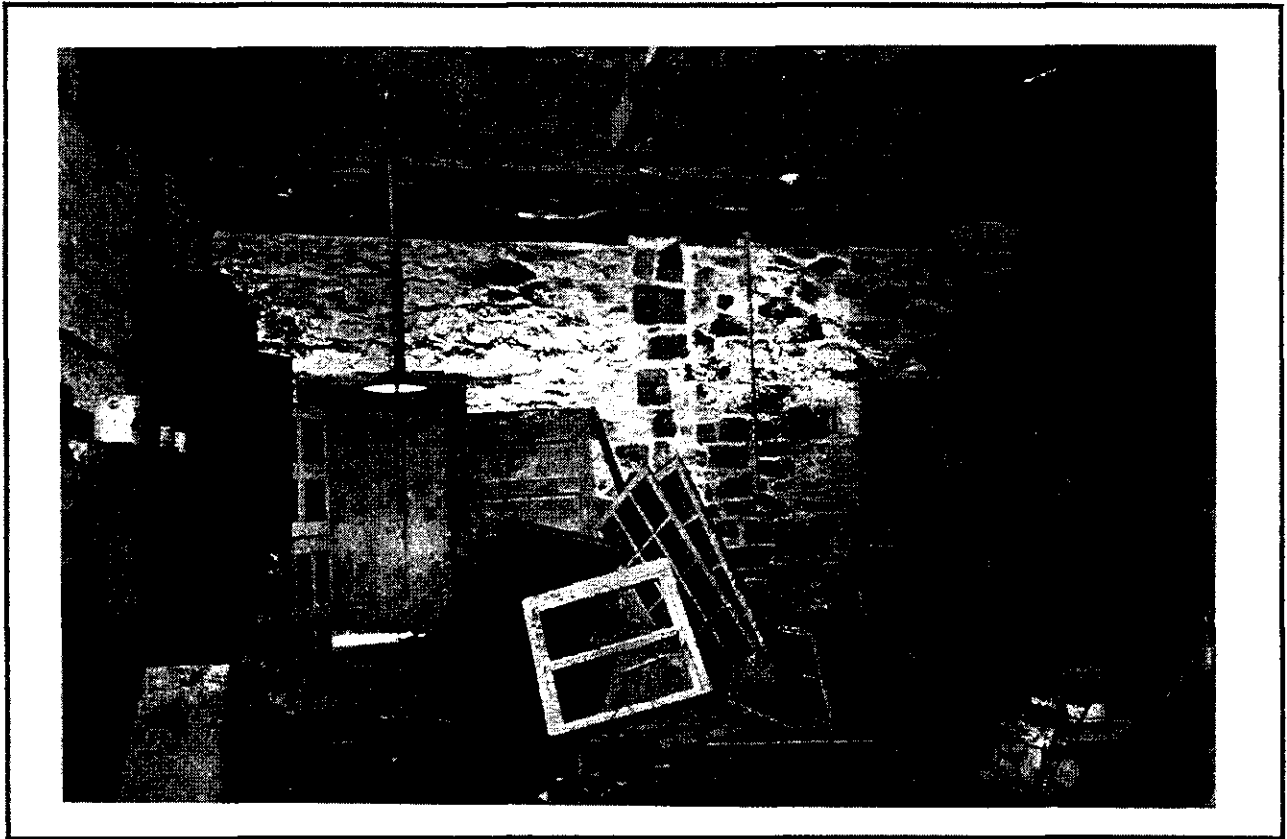
Kingtown Mill, interior ground floor, view of northeast section of building, facing east. Note stairway adjacent to stone wall on right of photo.
Date: May 9, 1995
Photographer: Lauren C. Archibald

The first floor of the mill building has three rooms. The largest room, and probably the oldest, is located in the northeast corner and has a wood floor and stone walls. Large beveled, mortise-and-tenoned wood beams run the length of the ceiling. At the south wall, a deep, linear trough that may have served as an overflow area is now filled with debris and standing water. This large room with trough appears to have been the first part of the mill to be built. An arched opening with stone headers is evident in the south wall of this trough area. On the south side of this wall is another, deeper trough area that served as the wheel pit. It is also partially filled with water and contains the remains of a wheel axle supported by a stone pier. On the upper south wall of the wheel pit is a rectangular opening which served as the entrance for the headrace into the wheel pit. The size and description of the trough on the first floor, approximately 10' x 40', makes it a major element of the ground floor of the building. Inaccessibility hindered examination to further determine what its function was in the powering of the mill. The depth of this feature could not be determined due to the presence of debris.

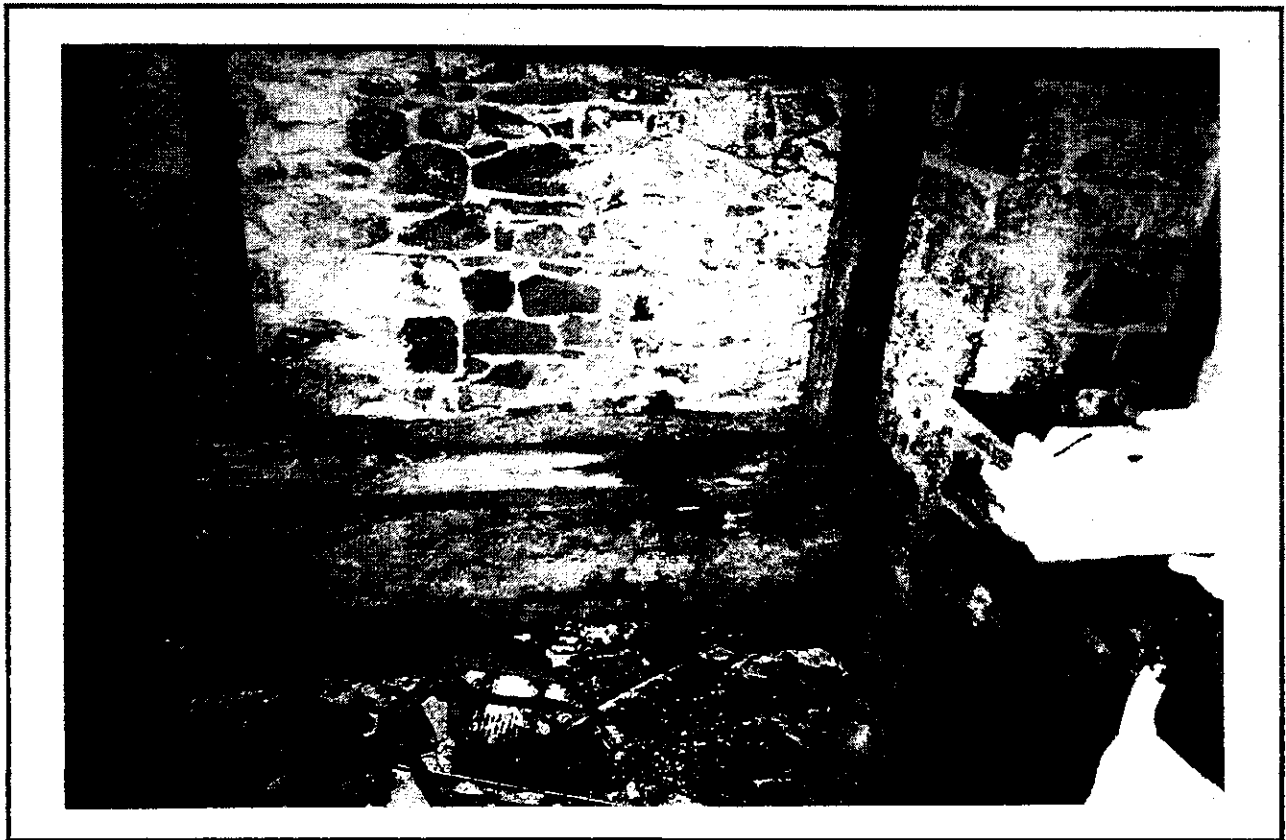
Kingtown Mill, interior ground floor. View of southwest corner of main block, showing deep recessed trough area. View looking southwest.

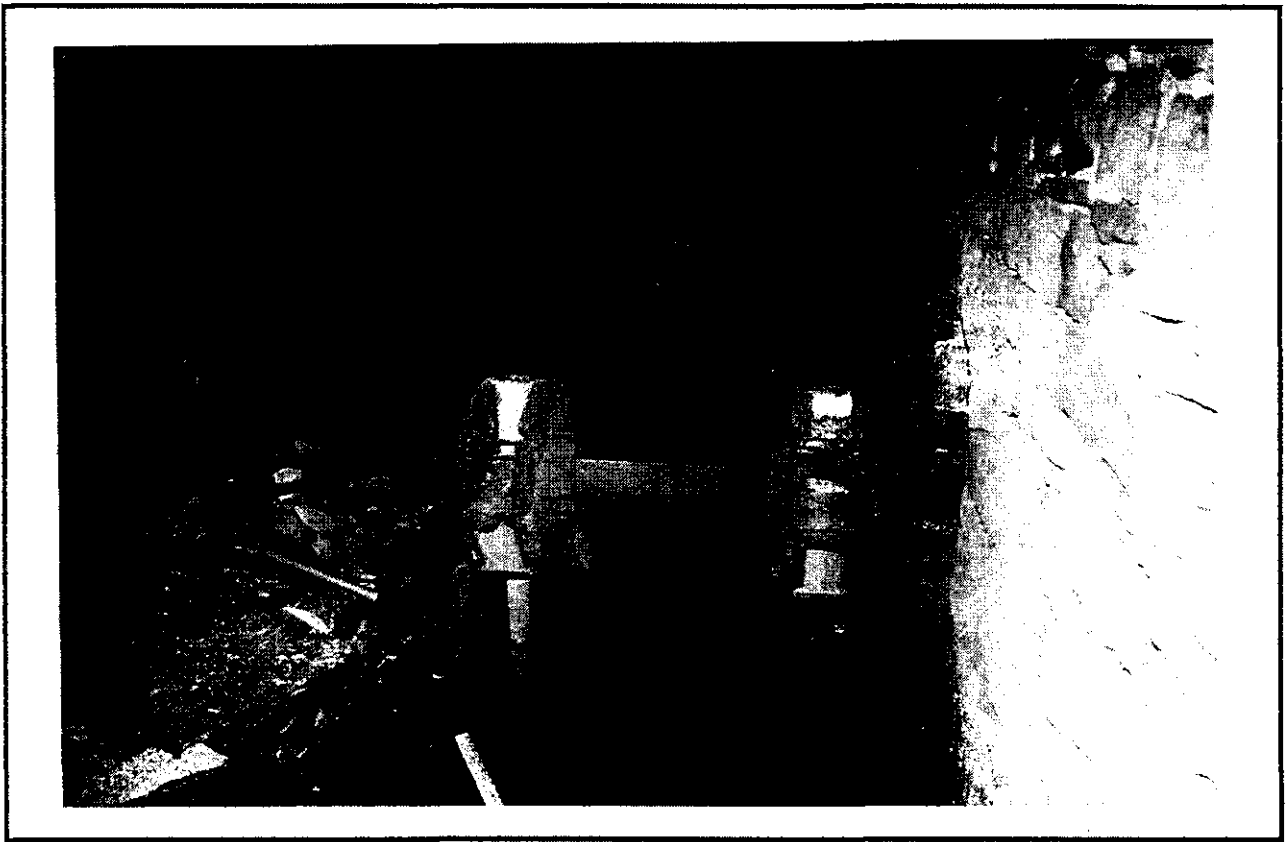
Kingtown Mill, view of wheel pit on south side of building, showing machinery and stone support on left of photograph. Note two bevel gear wheels.

The later frame addition on the south side of the main block was built on top of the wheel pit, which housed the waterwheel at ground floor level. Like the main block, it is built of stone up to the first floor, and capped with a second story with a standing-seam metal roof. This frame superstructure, which runs along the south side of the building and extends past the east elevation, was apparently added after the main block was constructed. At the southeast corner, a concrete block foundation extends beyond the gable end of the building, and it now encloses what had previously been an exterior wall on the southeast corner of the building. The roof is pierced by two small chimneys. Fenestration is irregularly spaced on this addition, and the window and door openings are boarded up.

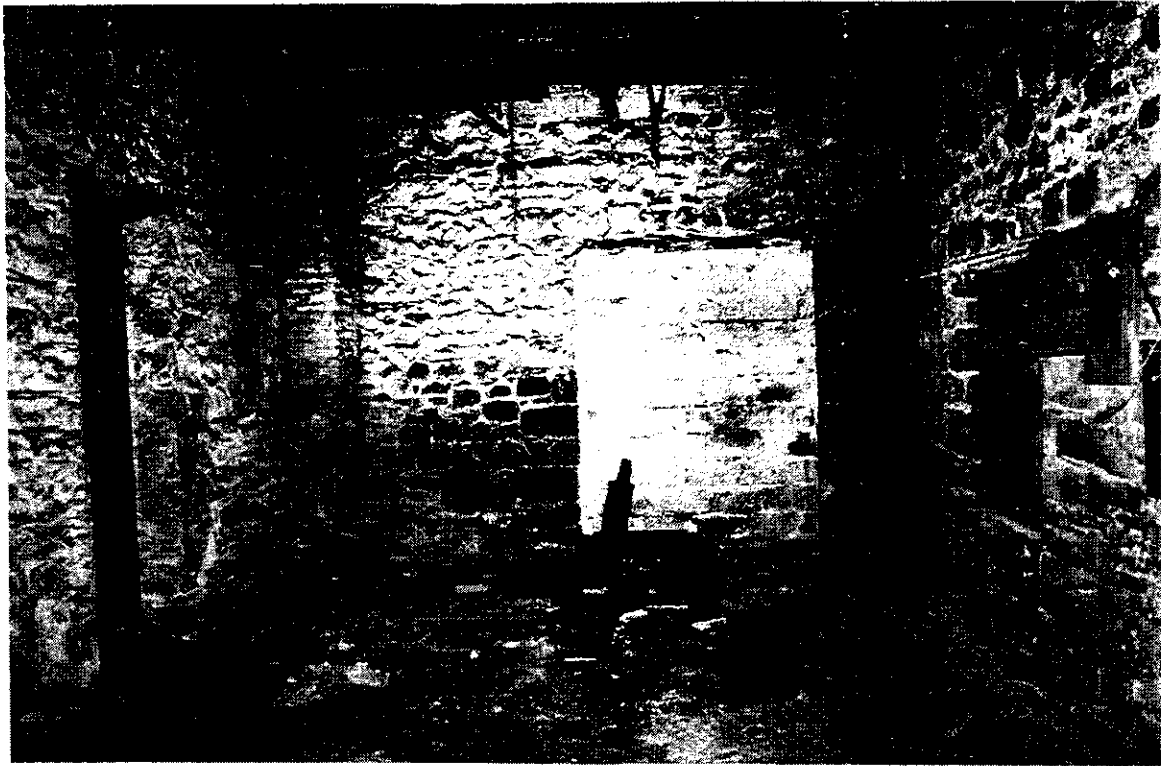
Kingtown Mill, interior, ground floor, northwest room, view of west and south walls. Note chimney in corner on left of photograph, and sealed door and window openings.

Two other rooms were added behind and to the west of the main northeast block. These two open rooms also exhibit stone walls, and have concrete floors. The northwest room has a

chimney in the southwest corner. The larger room, which is directly behind the wheel pit area, has a bank of wood closets on the east wall. Neither room appears to have housed machinery. However, it is possible that the chimney in the northwest room may have been used as the flue for roasting the flax seed, a necessary step in linseed oil production. Two stairways, one in the southeast corner of the main block, and one in the southwest corner of the building, lead to the second floor.

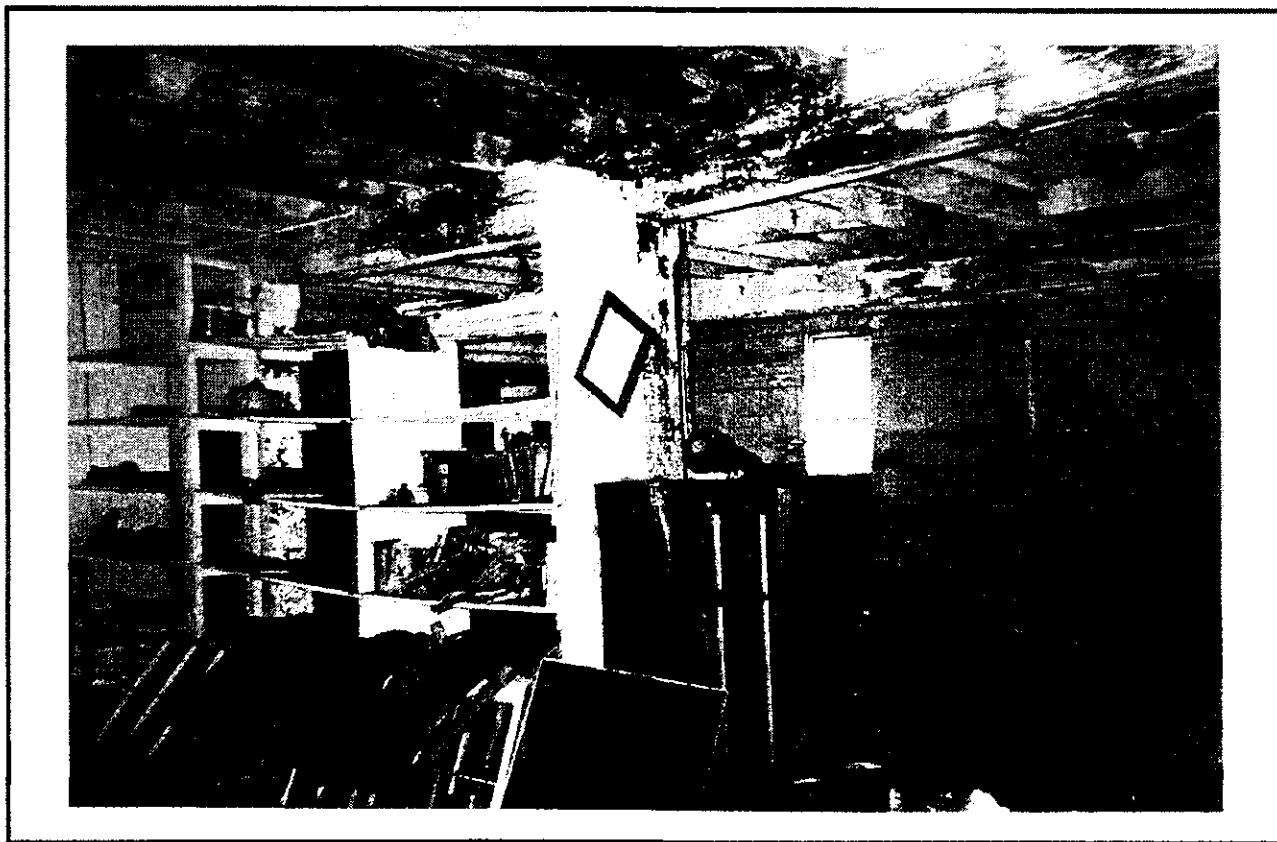
Kingtown Mill, interior second floor. Main block (northeast room), view toward northwest, showing shelving and storage area.

On the second floor there are a total of eight rooms. The principal second floor space is the northeast room, which has exposed wood framing and contains shelving and probably served as a supply area. The other rooms on the second floor of the mill apparently were used for offices and storage. Some of them, such as the room in the southeast corner, have beaded, horizontal siding and a glazed wall. Other rooms on the west side of the mill have wood wainscoting and fluted wood trim with bulls' eye designs around the doorways and windows. Others, such as the room in the far northwest corner, are plain, with a drywall ceiling and plastered walls.

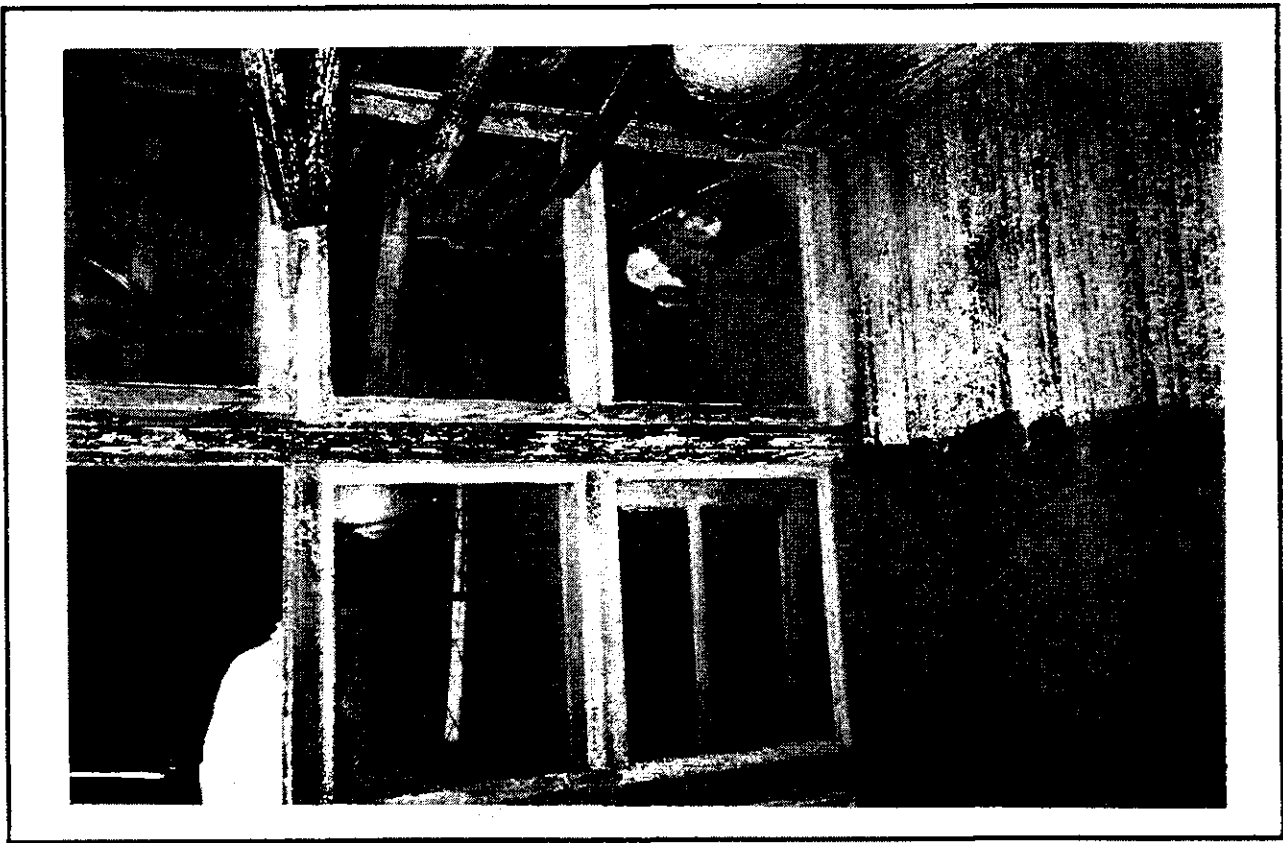
Kingtown Mill, interior second floor addition on south side of main block of mill building. View of southeast room, looking northwest. Note glass partitions and beaded wood panelling in wall.
Date: May 9, 1995
Photographer: Lauren C. Archibald

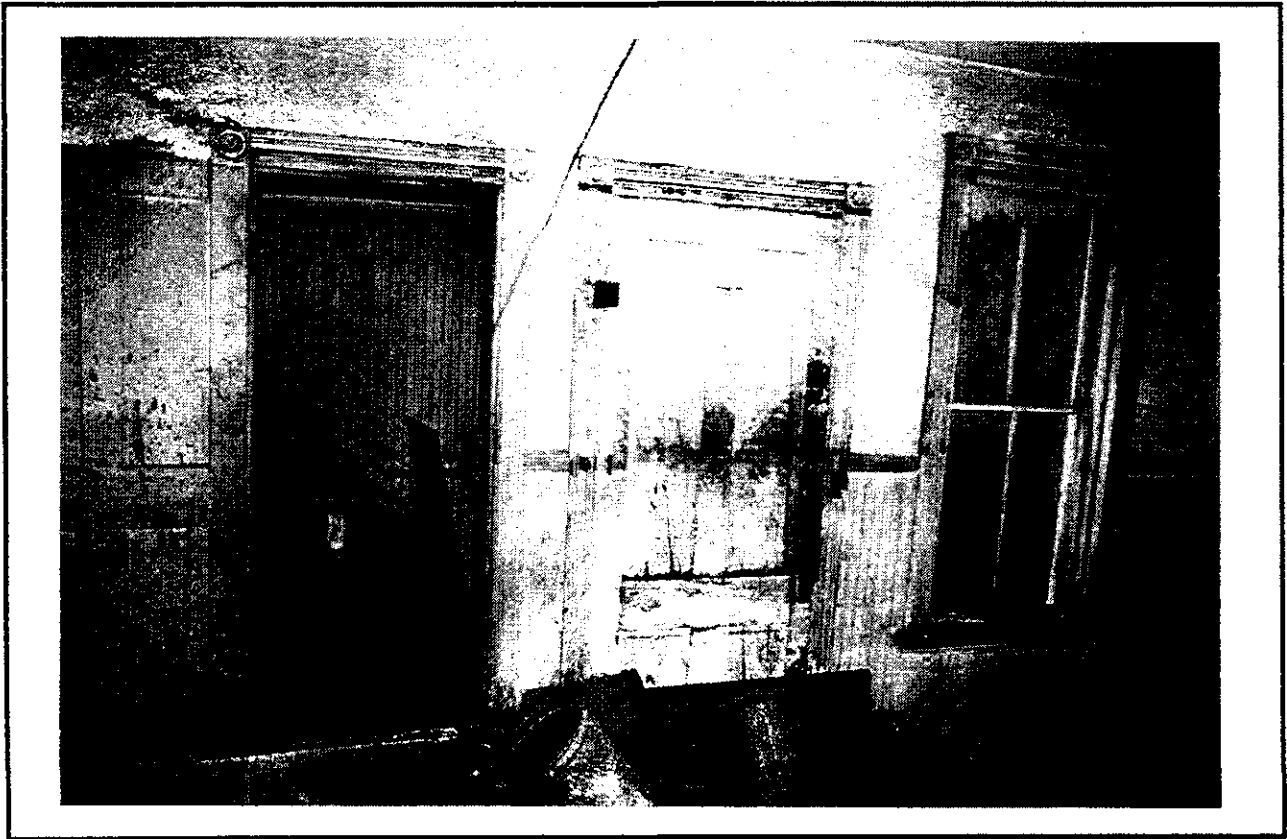
Kingtown Mill, interior second floor. View looking at south wall of southwest room, showing wainscoting and decorative door surrounds.

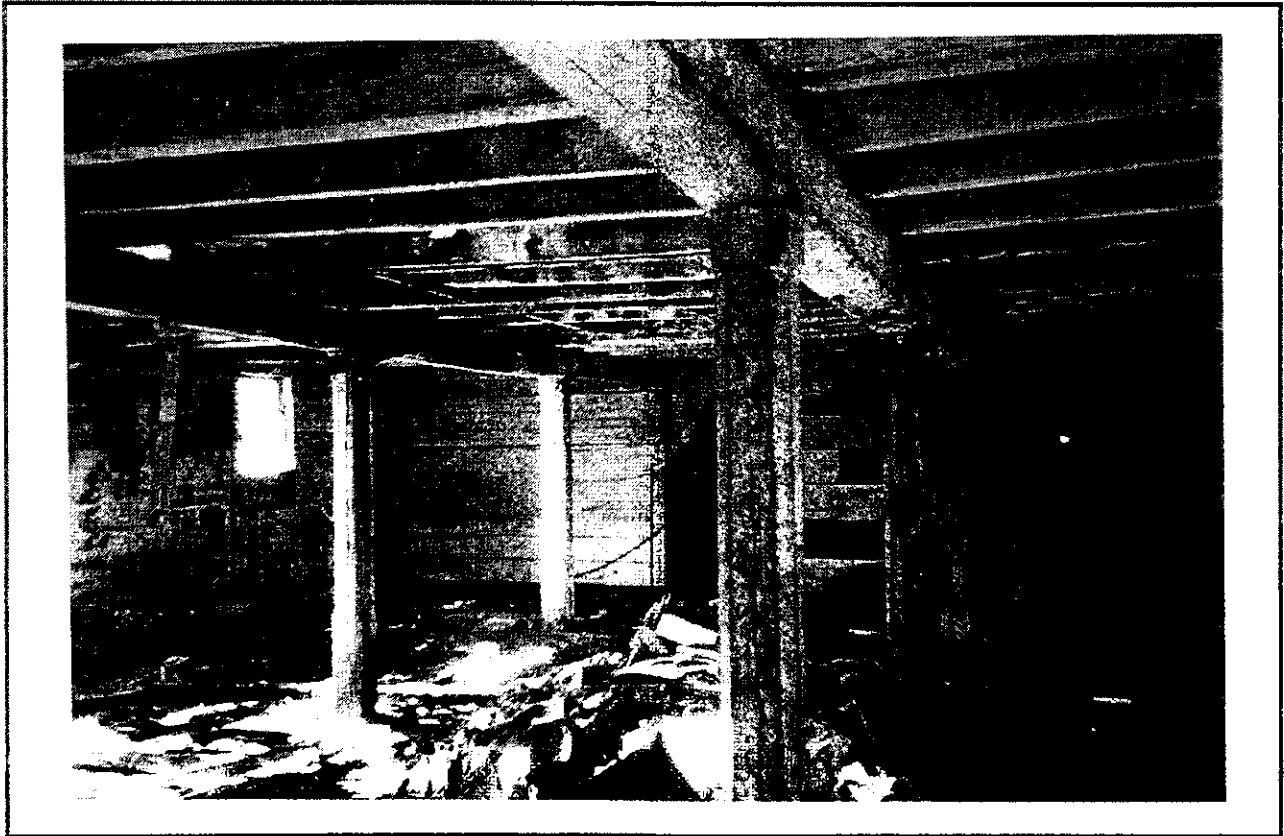
Kingtown Mill, interior, third floor. Shows overview of floor and framing system. Note beveled support posts.

The third floor contains five rooms. The largest room in the main block is found in the northeast part of the building and probably served as a storage area for raw materials. The wood framing is exposed, including heavy, beveled wood posts. Floor boards are of random width. The hoist system was located in the peak of the gable on the east wall. In the floor near the east wall, a large square opening was observed leading up to the hoist. While this principal room is clearly a plain, functional space, the smaller rooms behind and to the west of it have decorative appointments such as fluted wood door surrounds and base boards. One other room has wood planking on the walls, and another has stuccoed walls and a replastered ceiling. The fourth floor (attic level) was inaccessible in 1995.

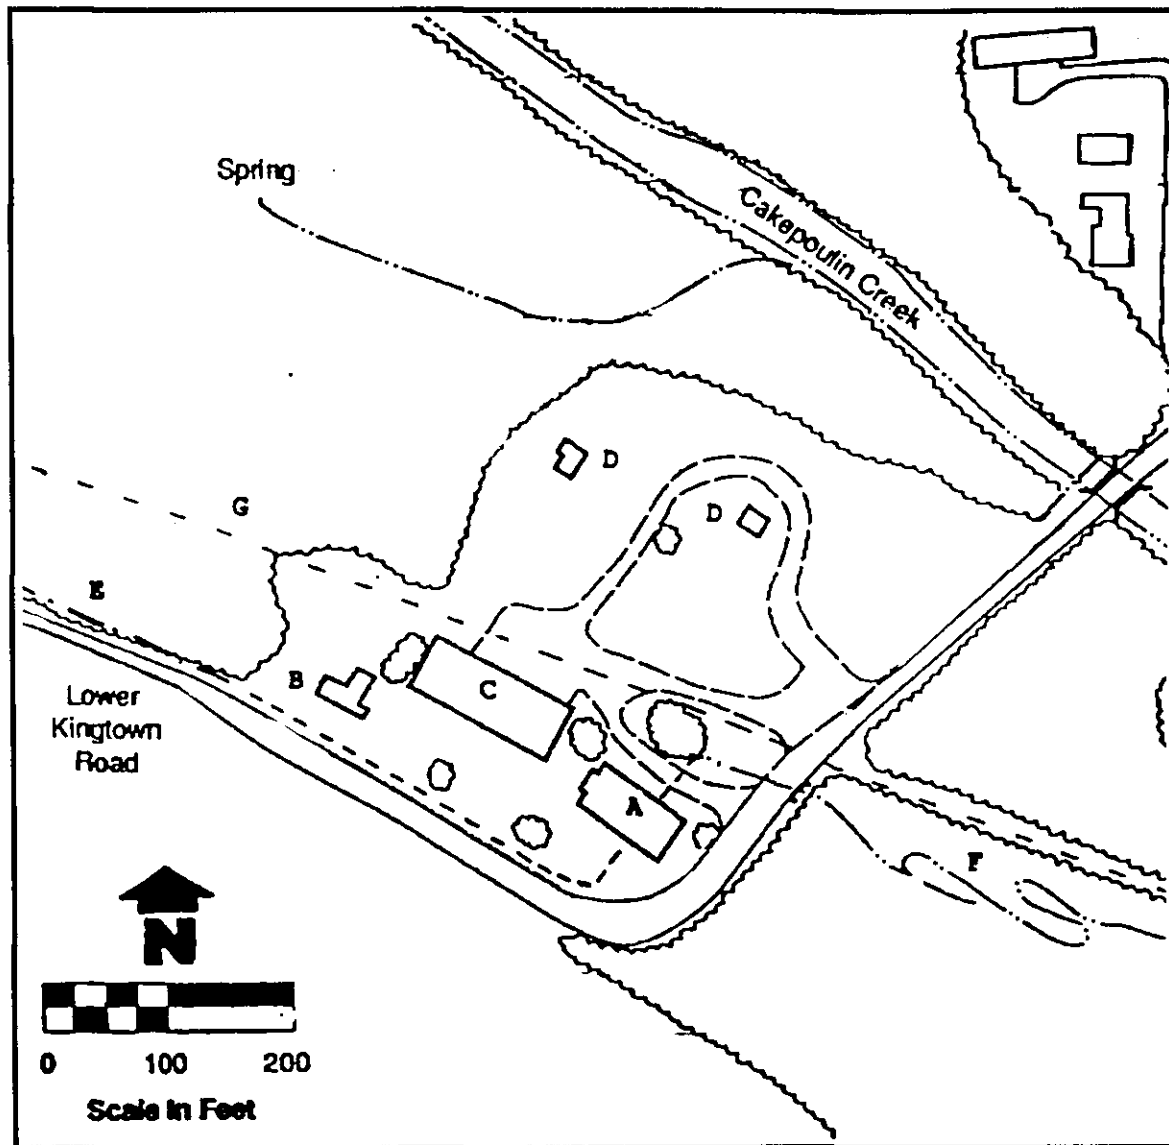
Kingtown Mill site. A = Mill; B = Myers House; C = Warehouse; D = Outbuildings; E = Headrace; F = Tailrace; G = Former railroad spur. Adapted from Porter 1989.

Neither the headrace or tailrace are visible on the ground surface outside the mill although the course of the raceway is recorded on the 1873 Beers county atlas. The raceway, which originated over 3,000 feet to the west near the intersection of Lower Kingtown Road and Cakepoulin Creek, is still clearly visible along the north shoulder of Lower Kingtown Road west of the mill.
